PUBLIC ROADS

A JOURNAL OF HIGHWAY RESEARCH

VOL. 13, NO. 4

Page
Stabilization by Drainage of Muck and Sand Fill	57
The Segregation of Water in Concrete Placed in Deep Forms	64
Gasoline Taxes, 1931	70

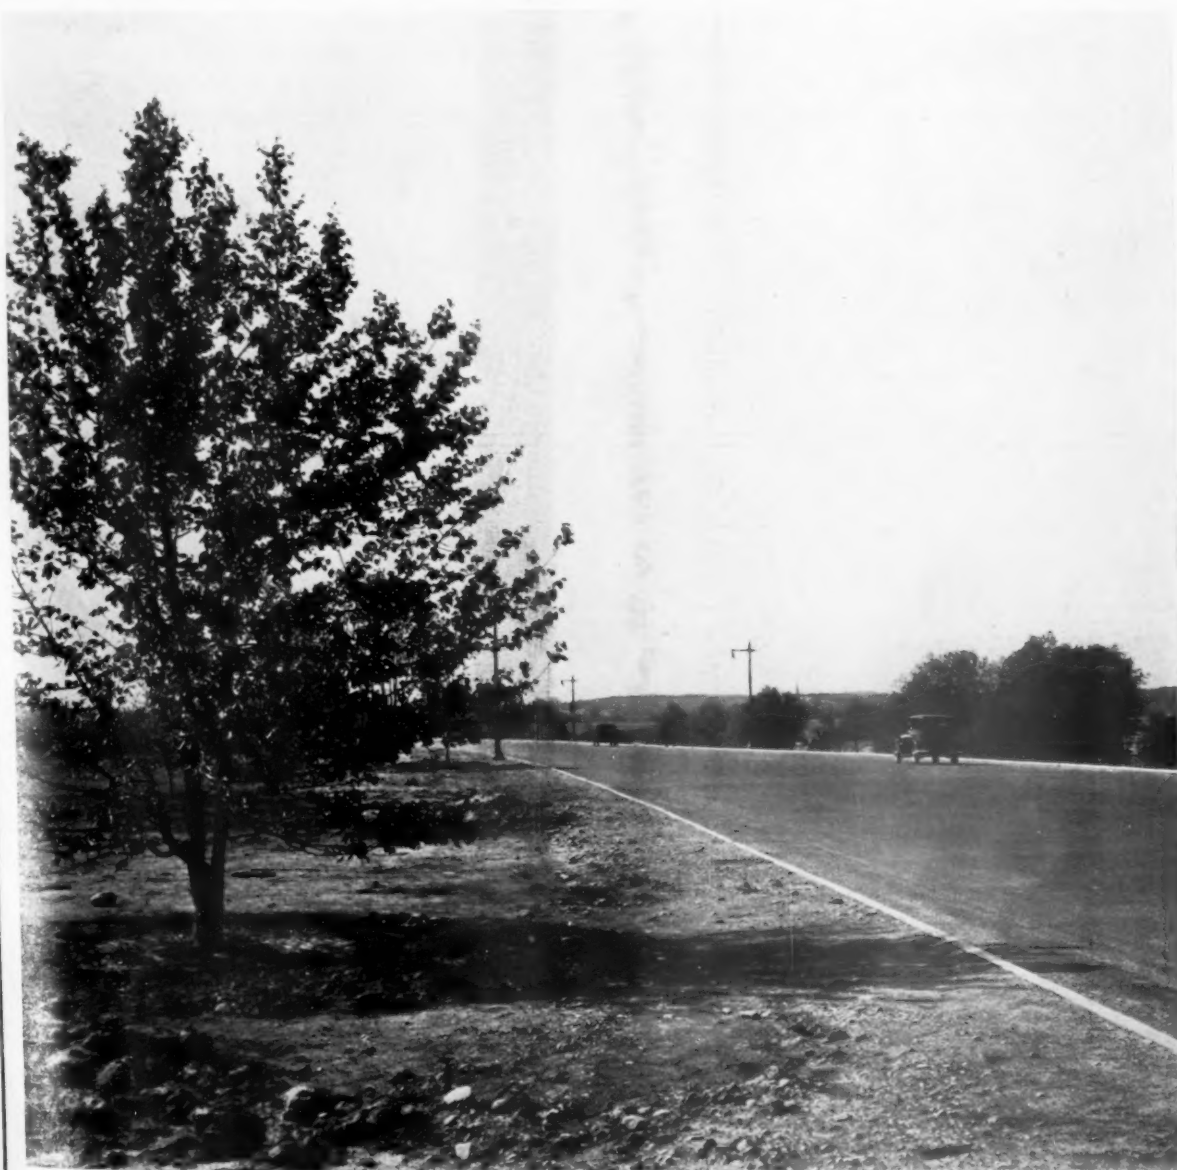
SECTION OF MOUNT VERNON MEMORIAL HIGHWAY ON COLUMBIA ISLAND, D. C.

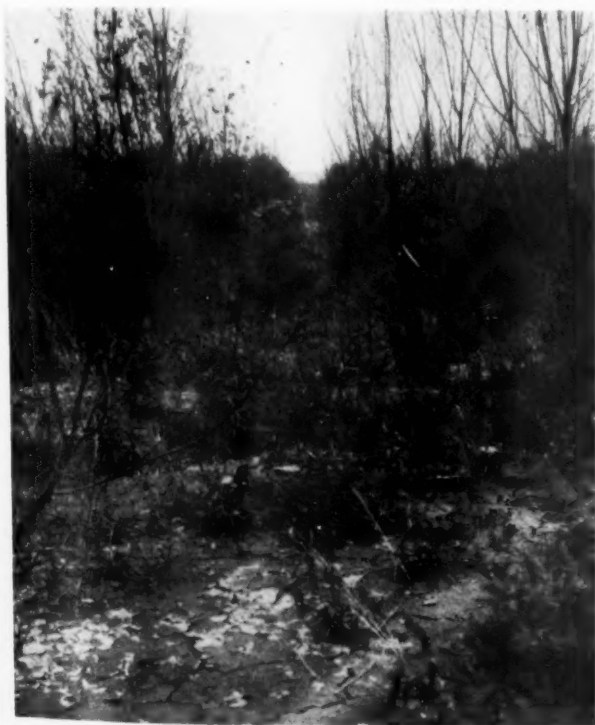
FIGURE 1.—LOOKING NORTH FROM STATION 13+00, ALONG THE CENTER LINE, BEFORE DRAINAGE

At the time it was desired to start grading operations on Columbia Island a section about 300 feet in length between stations 10+00 and 13+00 (see fig. 1) was covered with water and was so unstable that a person attempting to walk along the center line would sink in to his knees.

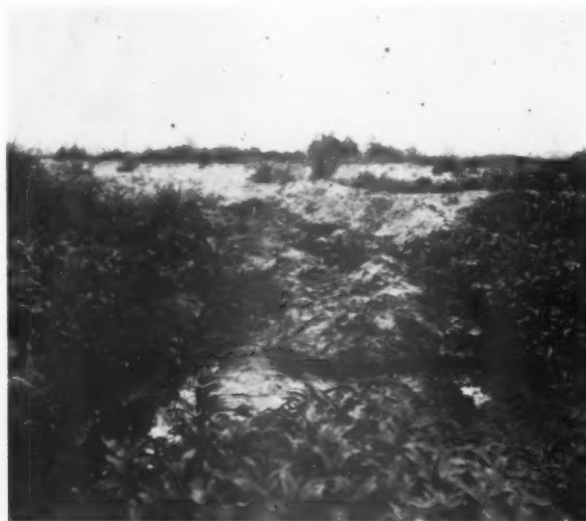
FIGURE 2.—WET AREA AT STATION 20+00. POWER SHOVEL WAS STUCK AT THIS POINT

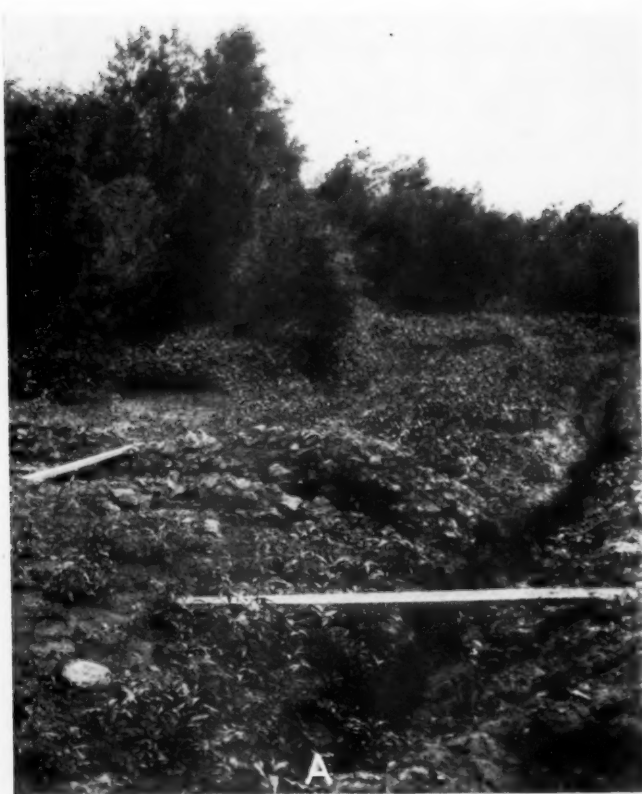
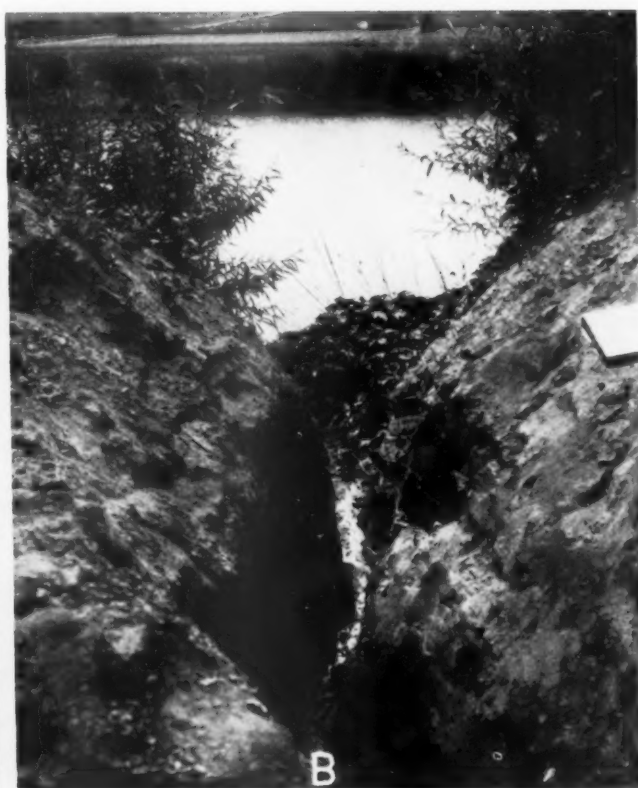
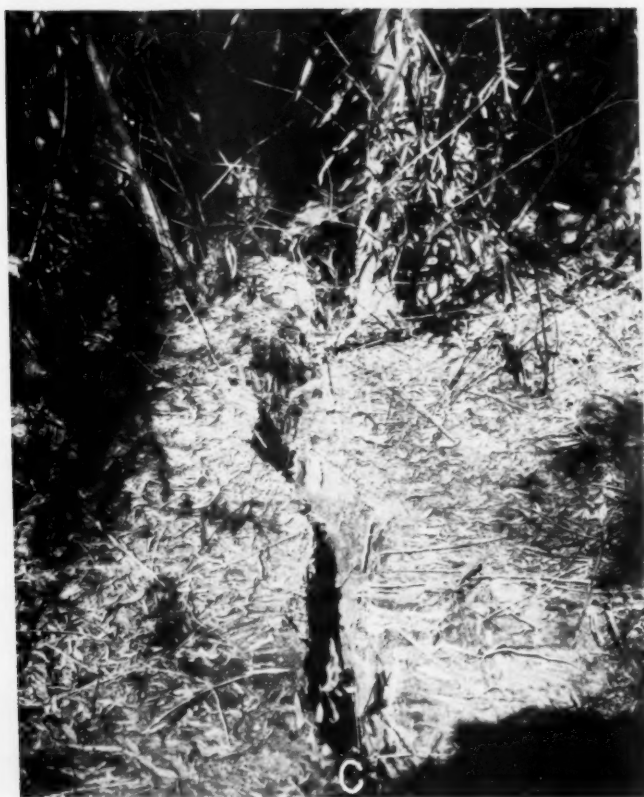
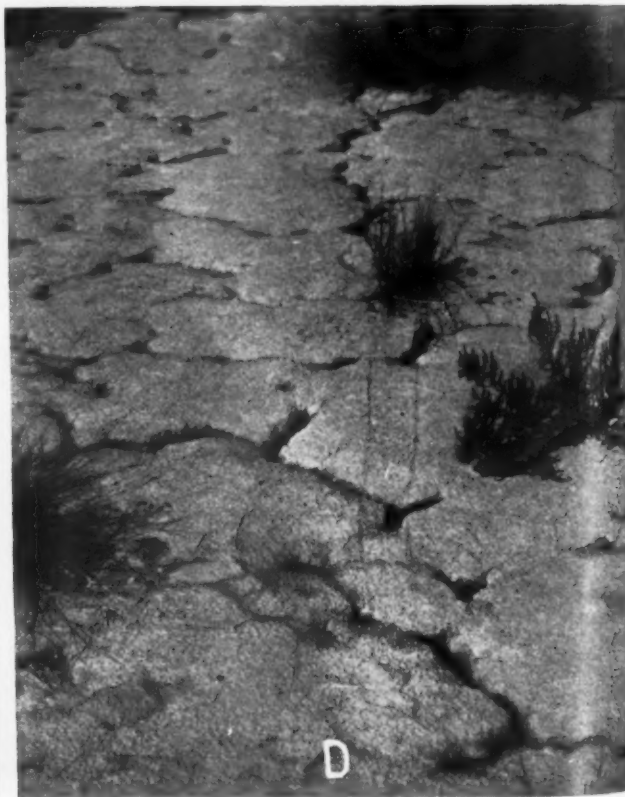
FIGURE 7.—STEPS IN THE DRAINAGE OF COLUMBIA ISLAND

A.—Ditches for removing surface water.

C.—Typical shrinkage crack in wet area after drainage.

D.—Shrinkage cracks in soil after drainage.

through the muck to the sand. The material close to the trench would begin to drain and as it dried out cracks were formed. These cracks, illustrated in Figure 7, C and D, extended back from the ditch and served as water carriers and so the whole area was gradually drained.

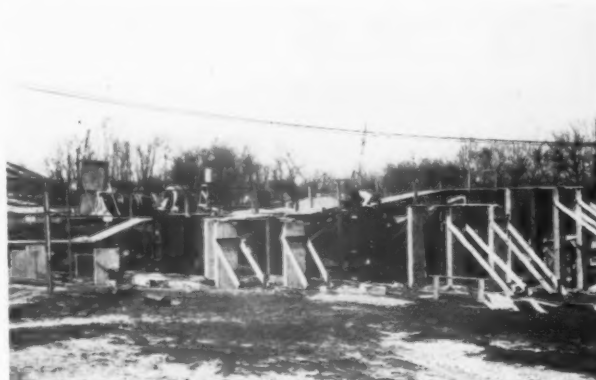
FIGURE 3.—GENERAL VIEW SHOWING HARDENED COLUMNS OF DIFFERENT HEIGHTS, AND FORMS BEING RESET

tion in the buggies was divided between the two sections of the forms. Cylinders were made from concrete taken from the mixer as the columns were being cast. In Figure 3 a general view of the project is shown.
